by Mike Irby, Director of Engineering and IT
Clear Channel Radio, Tucson

Continental Electronics' New 816HD Debuts at Tucson's KRQQ

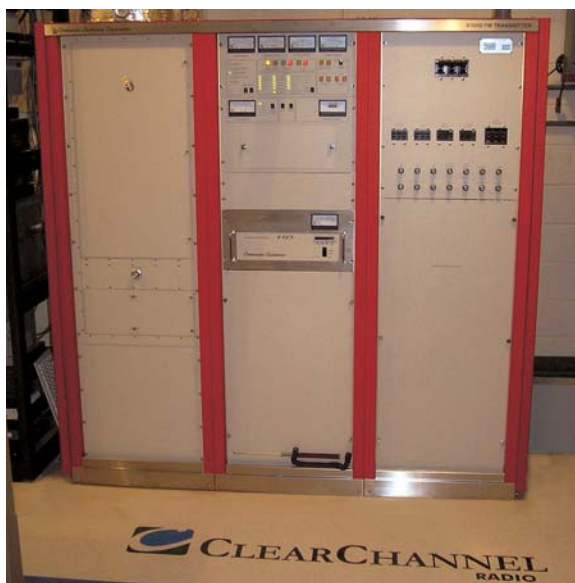
Continental Electronics 816HD Transmitter

Continental's answer was the new 816HD-series transmitter with low-level combining. This transmitter amplifies both the analog and digital signals using common amplification and does so while with the same footprint as our existing analog transmitter.

Briefly put, using a new IPA section and a 4CX20,000E tetrode PA tube allowed the necessary modifications to the transmitter so that it meets the NRSC recommendations on spectral emissions. Although not necessary for all power levels, the Continental 816HD uses pre-correction to comply with, and significantly exceed, the NRSC mask while generating analog power levels up to 21 kW.

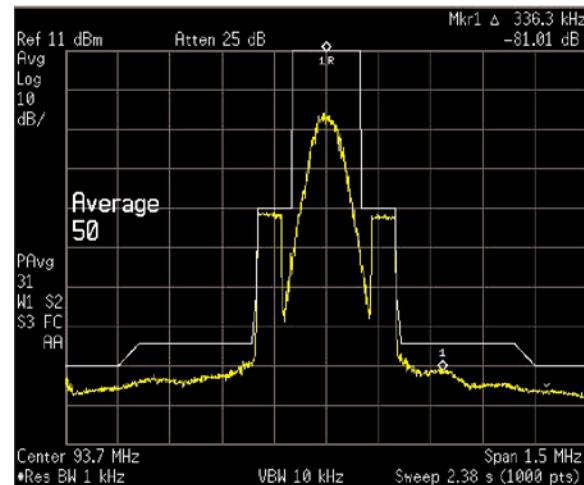
One of Clear Channel's key stipulations for equipment acceptance was that the 816HD meets the NRSC spectral mask with full modulation applied. The spectral images we measured showed that the 816HD was well within the mask, regardless of power or modulation level.

816HD Spectral Plot with 100% Modulation

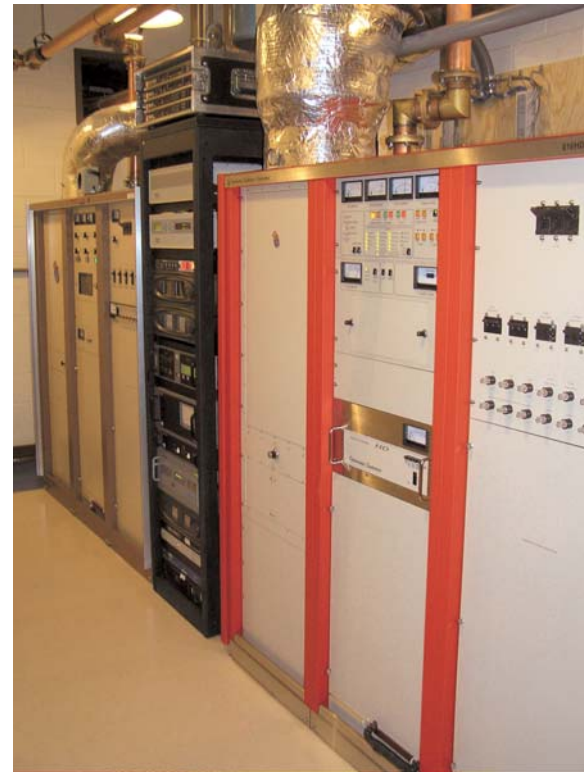
KRQQ's 816HD transmitter
alongside the 816R-3 (now the Backup).

As with many stations using mountain top facilities, enlarging the room just was not an option. Inside the transmitter room was a 20 kilowatt Continental 816R-3 serving as the main transmitter. Next to that was a Collins 830F that was limping along as our backup transmitter; the new unit would need to fit on the same floor space.
